# Investigation of Frequent Failure of Francis Hydraulic Turbine Guide-Vane Shear Pin of Shiroro Hydro-Electric Power Station

**Abstract:** Francis Hydraulic Turbine Guide-vane shear pin is a mechanical sacrificial component designed to break when the mechanical overload arises to prevent severe damage of guide-vane, which is an expensive component in the turbine assembly of hydro-power station. The pin is expected to serve for a minimum period of 10 years under normal working condition before failure occurs as obtained in most hydro-electric power stations globally. The shear pins in Shiroro hydro-electric power generation station located in Niger state of Nigeria were found to be frequently failing within a year of operation before reaching its predetermined load. This research investigated the possible causes of the frequent failure of the shear pins with a view to proffer solution. Analyses of the existing shear pin with respect to material specifications, micro-structural analysis using spectrophotometer where both visual and scanning electrode microscopy (SEM) was done in addition to mechanical tests to ascertain conformity with standards. The results showed that the shear p

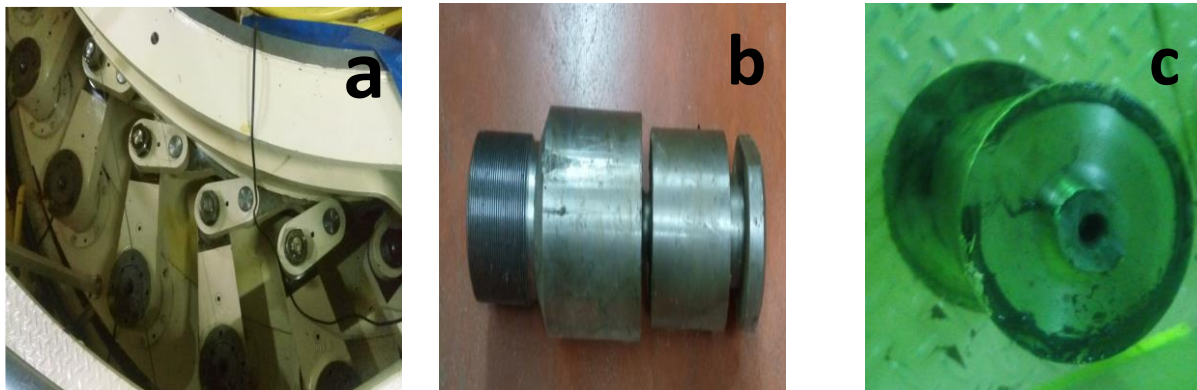
Figure 1: (a) Arrangement of Shear Pin with Turbine Regulatory Ring, (b) Shear Pin and (c) Fractured Shear Pin

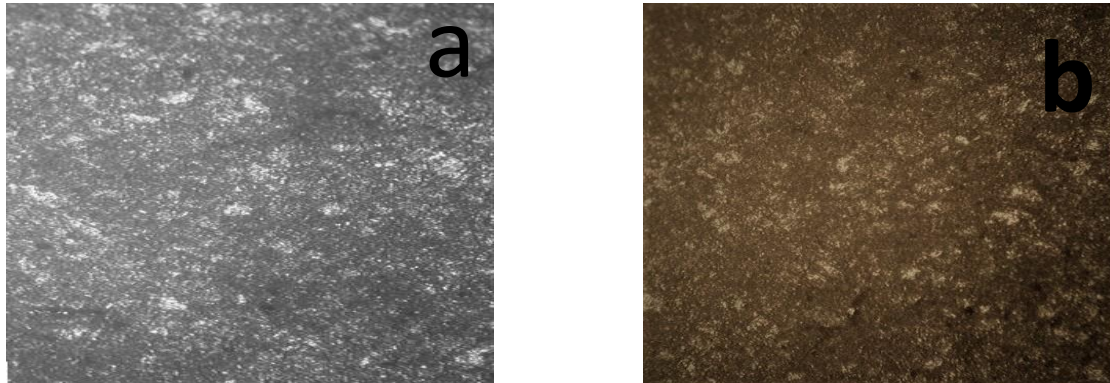
Metallographic examinations on some selected failed shear pins shows uniformity and close resemblance in their microstructures that are hardly distinguishable as shown in Figure 3. This inferred that the frequent failure of the shear pins could not have been due to discontinuity or segregations in the phases. The microstructure revealed dispassion of ferrite, retained austenite and traces of tempered martensite. The results indicated that the shear pin material was tempered after the preliminary manufacturing stage to impart some properties that will ensure durability of the pins as specified in the requirements for the shear pin production.

Figure 3: Microstructure of Two Samples of Shear Pin Material Showing (a) Ferrite and (b) Tempered Martensite Structure

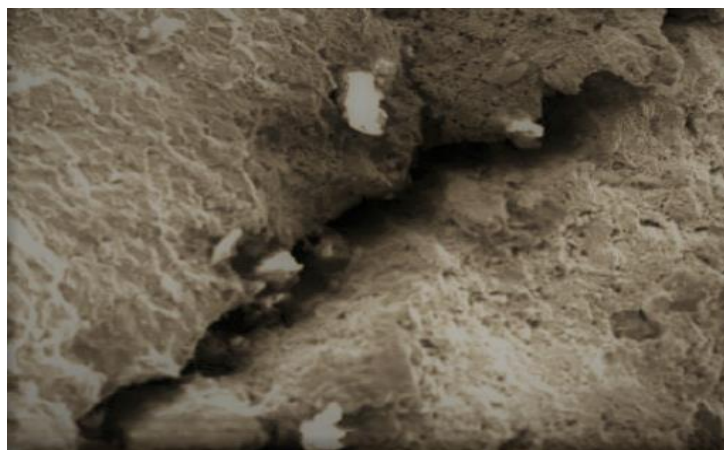
Figures 4 and 5 shows the result of fractography of the failed shear pin of the Shiroro hydro-electric power station done with 25kV accelerating voltage applied for the SEM analysis. From the figure, Micro cracks and oxide

particles were seen on the surface of the fractured shear pin which could most likely be due to overload or low cyclic fatigue phenomenon likely to be caused by the station's operating condition with frequent load rejection that causes water hammer or similar effects (Suresh, 1998; Blazek, 2001; Schijve, 2001; Kumar et al., 2012; Shalak, 2019). Visual observation and the fractographic analysis showed that the fracture was initiated on machining marks along the surface of the shear pin near the neck.

Figure 4: Result of Fractography of a failed shear pin taken with 25 kv @ X200 magnification factor

- i) Adopting spinning reserve system not free governor system for operating Francis Hydraulic turbine.
- ii) Improving the transmission and distribution network so that the power generated can be evacuated without rejection.
- iii) Further analysis on the shear pin frequent failure be carried out based on design and applied forces.
- iv) Analysis of pressure effects at different points in the penstock, wave speed of water hammer and guide-vane closing time (wicket gate) be carried out to mitigate the effect of water hammer.

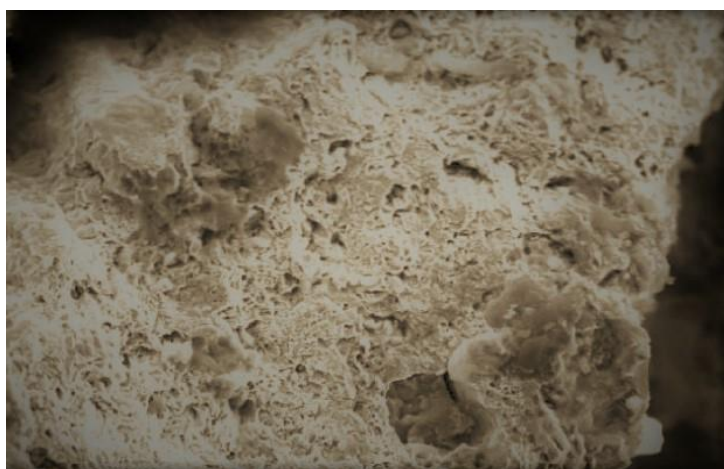
Figure 5: SEM at 25 kv Fractograph at the Neck Portion Showing Brittle Fracture at X200 Magnification Factor
