# Structural Modification of Proposed Reinforced Concrete Building

Thazin Thein<sup>a</sup>, Nwe Nwe Win<sup>b</sup>

<sup>ab</sup>*Department of Civil Engineering, Technological University (Mandalay), Mandalay, Myanmar*

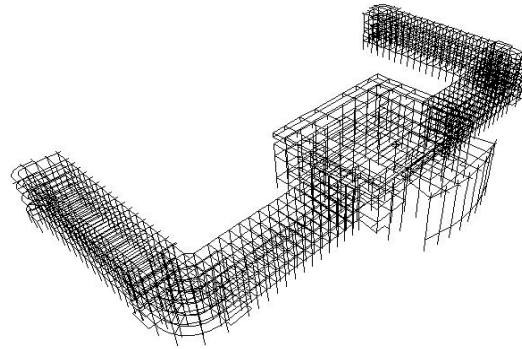
Fig. 1. 3D View of Proposed Building

In existing proposed building, the structure consists four expansions joint and is divided into five portions. The structure is symmetric and the portions are similar. Block 1 and 5 are similar and Block 2 and Block 4 are similar. Block 3 is middle portion. Proposed building of TU (MTLA) is three-storied R.C building. Length of building is 535ft. Width of building is 90 ft. Shape of building is U – Shaped. Height of foundation is 14.5 ft. Height of typical floor is 14 ft. Overall height of building

is 70.5 ft. 3D view and portions of proposed structure and elevation view are shown in Fig.1, Fig.2 and Fig 3 respectively. As material properties of proposed building, modulus of elasticity  $E$  is 3122 ksi, poisson's ratio  $\nu$  is 0.2, coefficient of thermal expansion of  $5.5 \times 10^{-6}$  in/in per degree F. Bending reinforcement yield stress  $f_y$  is 50000 psi, Shear reinforcement yield stress ( $f_{ys}$ ) is 50,000 psi, Crushing strength concrete  $f_c'$  is 3000 psi.

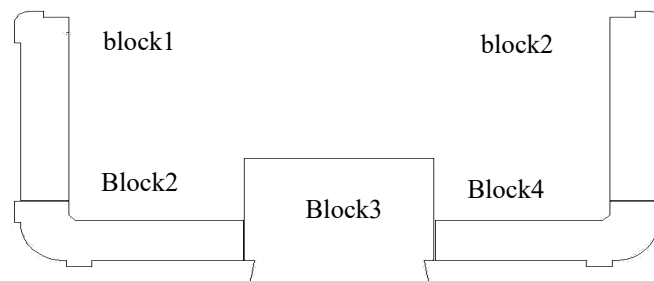
Fig. 2. Portions of Proposed Building

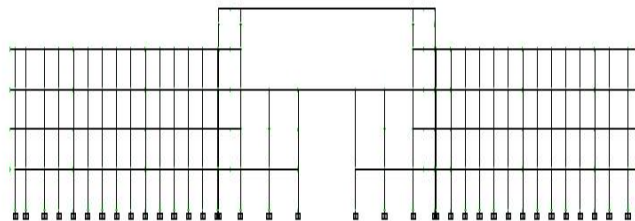
Fig. 3. Elevation View of Proposed Building
